# Developing guidelines for the seismic assessment of glazing systems

*F. Arifin, G. De Francesco, T.J. Sullivan and R.P. Dhakal*

University of Canterbury, Christchurch, New Zealand.

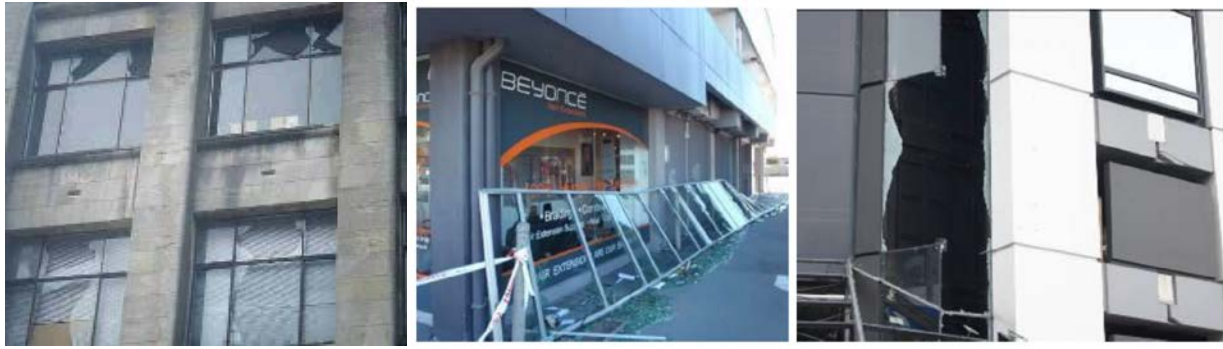
*Figure 1. Examples of glazing damage that occurred in the September 4th 2010 Darfield earthquake (Dhakal 2010) and the February 22nd 2011 Christchurch earthquake (Baird et al. 2011).*

Recent events, such as the 2016 Kaikōura earthquake and the 2010-2011 Canterbury earthquakes, have highlighted the damage earthquakes cause to glazing systems (Dhakal 2010, Baird et al. 2011). Figure 1 illustrates damage to glazing observed from the Canterbury earthquakes. Photos in the press (Stuff, 2017) of shattered glass on footpaths and reports that areas may be cordoned off because of the risk posed by falling glass remind us that the performance of glass windows/glazing in earthquakes can be a life-safety matter. There were many reports of injuries due to broken glass lying in egress routes following the Canterbury earthquakes. In addition, the repair of glass facades can be costly and time-consuming and accessibility to damaged parts can pose a significant challenge in many cases. Following the Kaikōura earthquake, due to the complexity of the repair work (including access) glazing repairs in downtown Wellington reportedly cost as much as \$50,000 per pane (Valli, 2017).

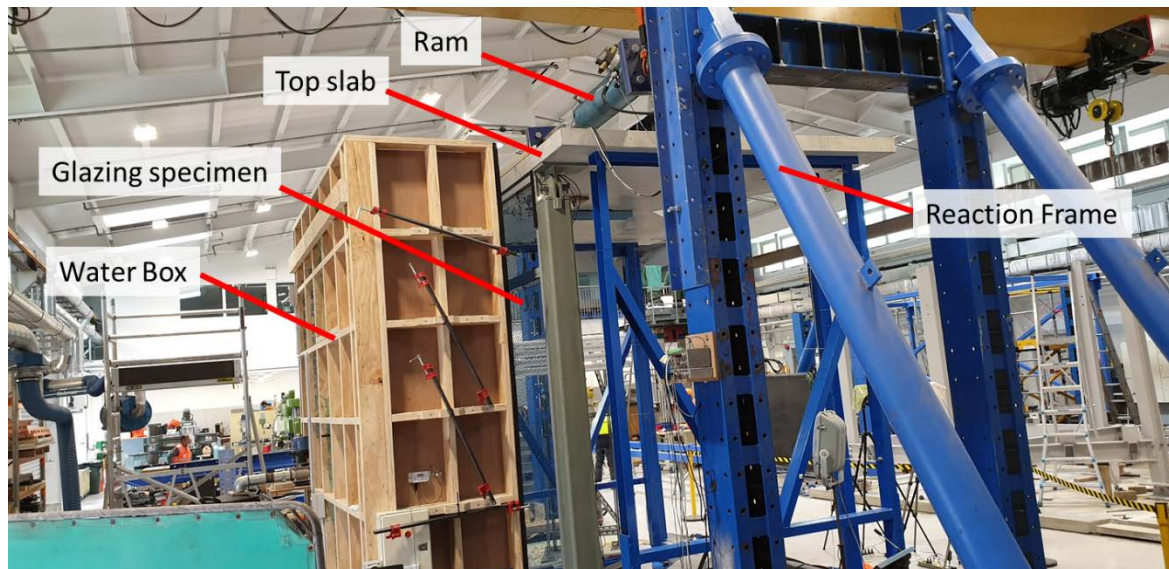
*Figure 3. Photo of water box, actuator, reaction frame and ram.*

The experimental set-up (Figures 2-5) consists of two concrete slabs (top and bottom), simulating building floors with a height of 3.6m, which were erected with two pinned steel frames at either end. The structure is fully pinned in the longitudinal direction and is not permitted to move in the orthogonal direction. The rig is connected to a hydraulic actuator which can impose roof displacements of  $\pm 300\text{mm}$  in the longitudinal direction and a force of 800kN. Two additional steel columns are added in the longitudinal direction to simulate floor columns creating an “opening” of 2.976m long by 3.385m high for installing the glazing system. A full-scale glazing system specimen is then installed in the opening which is then sealed on all four sides to ensure realistic building conditions. During the water penetration test, a weather simulator “box” made from timber is attached to the system fully covering the glazing system. An array of sprinkler nozzles 1800mm apart is mounted inside the timber box which is approximately 900mm deep as recommended by NZS4211. Water is then “sprayed” onto the glazing system simulating rain. This system is designed as such that after falling off the face of the glazing, the drained water is reticulated back to the water reservoir (via a pump). Furthermore, to simulate wind, an air blower is utilized to increase the air pressure inside the “box”. The air pressure could then be controlled via a differential pressure sensor and two “air bleeding” valves.

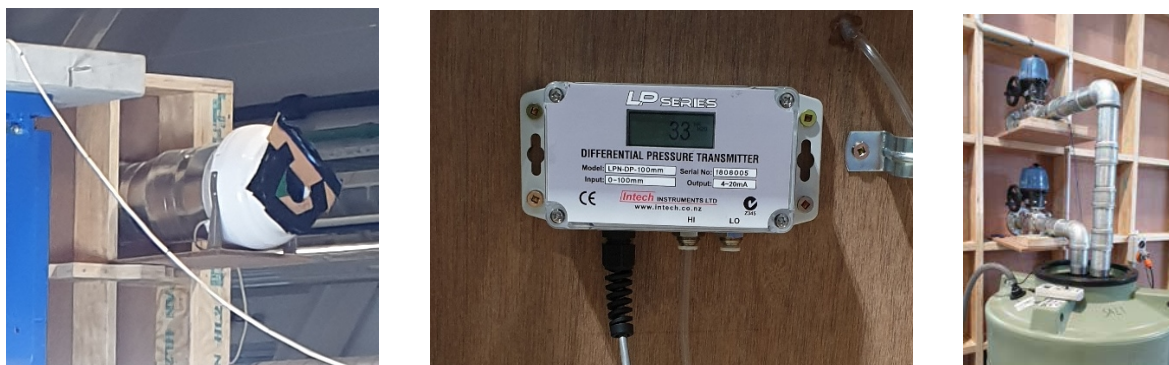
*Figure 5. Air pressure control unit. Air blower (left), differential pressure sensor (middle) and bleeding valves (right).*

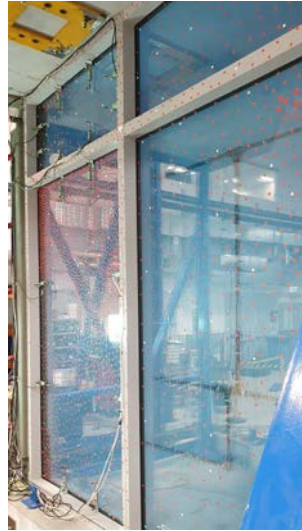
*Figure 6. Glazing Specimen.*

The first set of specimens are a common dry glazed curtain wall glazing system with four panes (Figure 6). The two bottom panes had small aspect ratios of 1.426m wide:2.56m tall and the other two top panes had larger aspect ratios of 1.426m wide:0.622m tall. The framing was made from aluminium which provided a glass clearance of 16mm. The aluminium frame is screwed on all four sides to the concrete slab and steel columns. The system is sealed with PVC wedges around all four sides of each glass pane and silicone around all four sides of the aluminium (two sides in contact with concrete, and two in contact with steel).

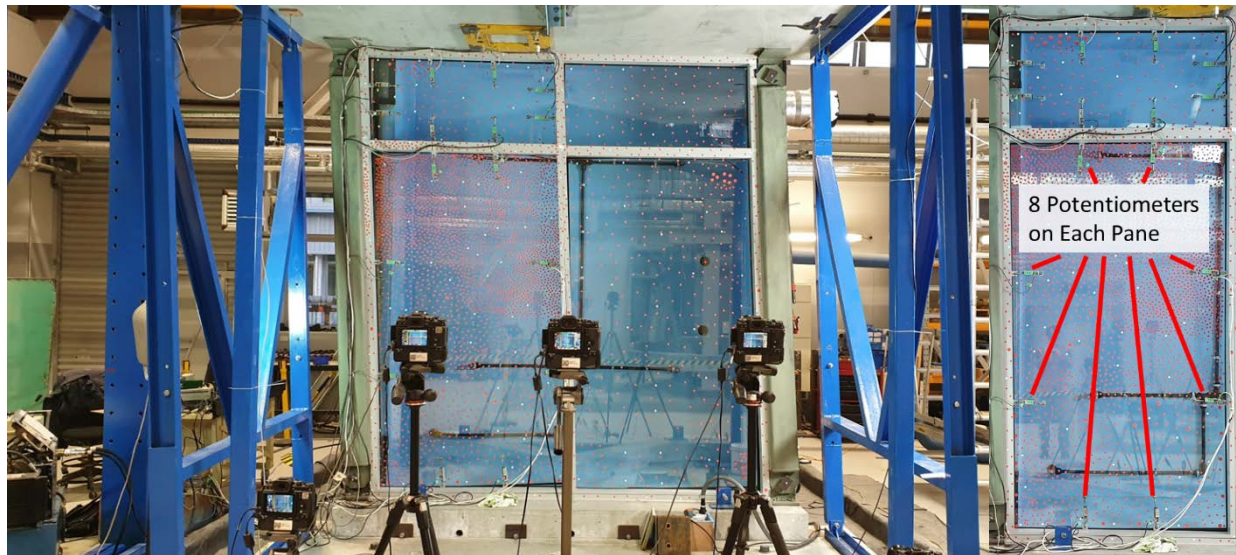
Figure 8. Photo showing glazing specimen and instrumentation used in the experimental testing, cameras and red dots used for particle-tracking (left) and potentiometers used to monitor displacements of panes relative to framing (right).

The rig was instrumented with a load cell to measure the force resisted by the actuator, a displacement transducer to measure the roof displacement, particle dots for particle tracking of the glazing system, and potentiometers to collect data on the rigid body movement of the glass pane with respect to the aluminium frame.

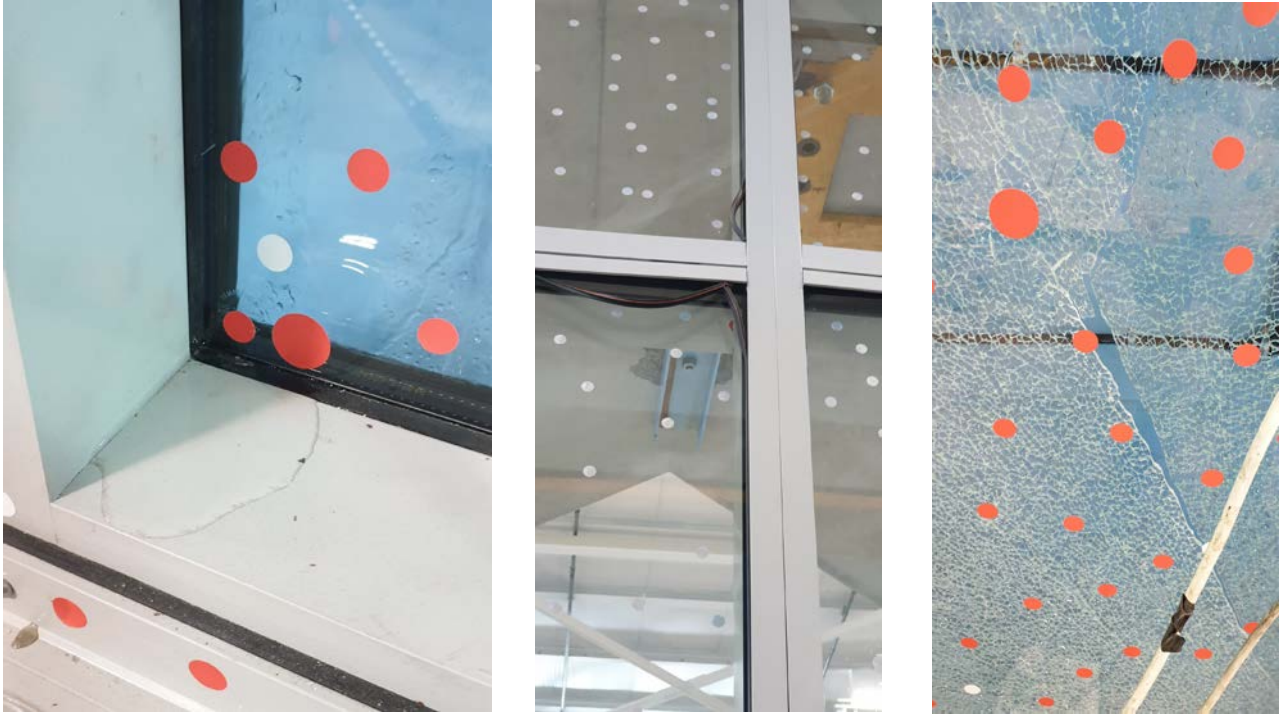
Figure 9. Damage states 1-water leakage(left), 2-gasket failure(middle) and 3-glass or frame failure(right).

Note that three damage states are considered for the tabulation of data, which are; DS1: loss of the water-tightness of glazing units, judged to occur when water first appeared on the inside face of the glazing (Figure 9); DS2: visual gasket failure in which gaskets were seen to have moved out of place (either jammed into framing or falling out) and would have prompted repair (Figure 9); DS3: failure of the frame or glass (either significant cracking or fall-out) (Figure 9).
